LAKE ALTOONA DAM

NDI I.D. NO: 532

PHASE I INSPECTION REPORT
NATIONAL DAM INSPECTION PROGRAM.

SEPTEMBER 1978

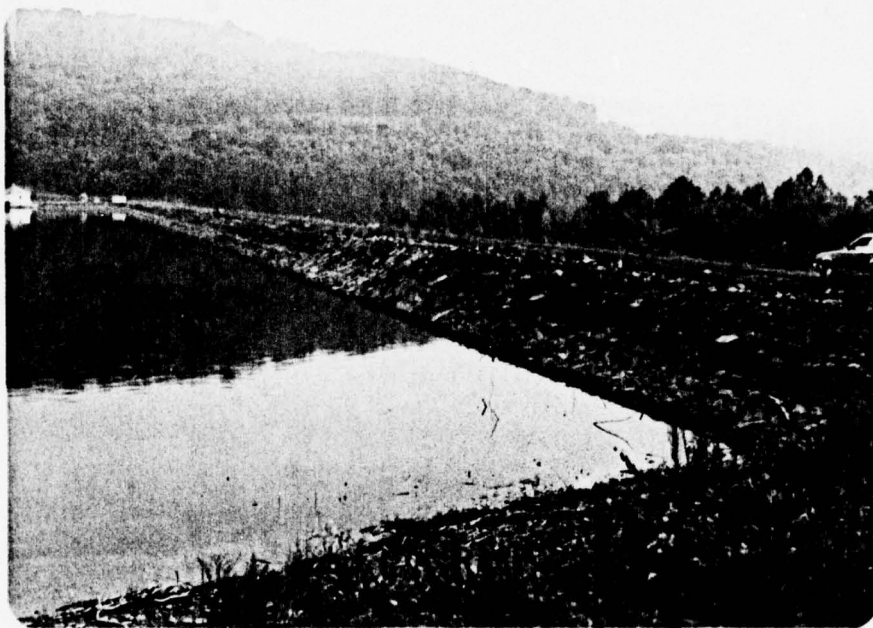
Upstream Face

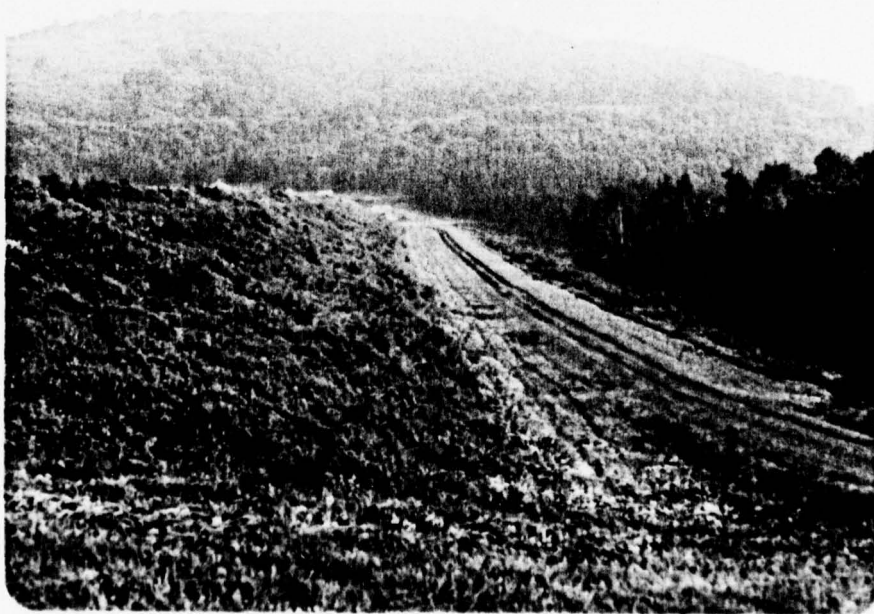
Downstream Face

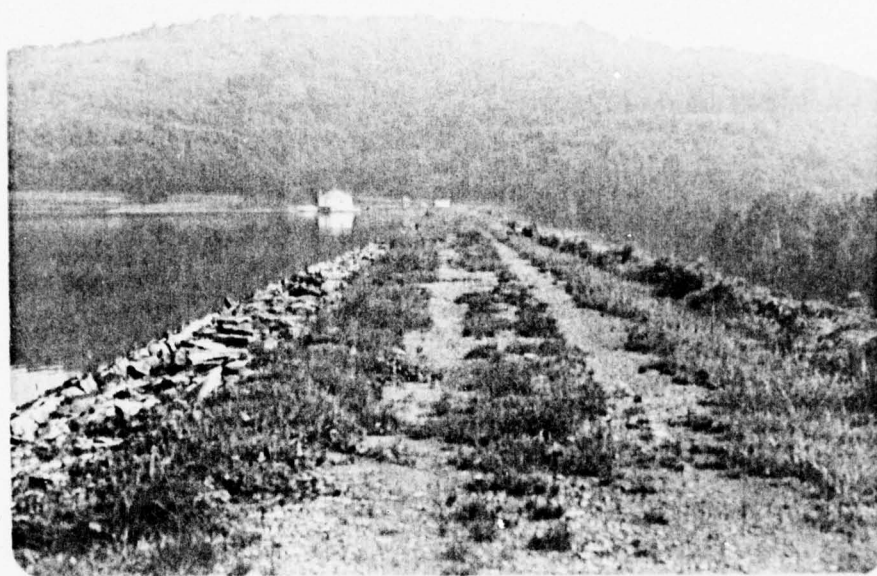
Photograph No. 1
Crest (looking north).

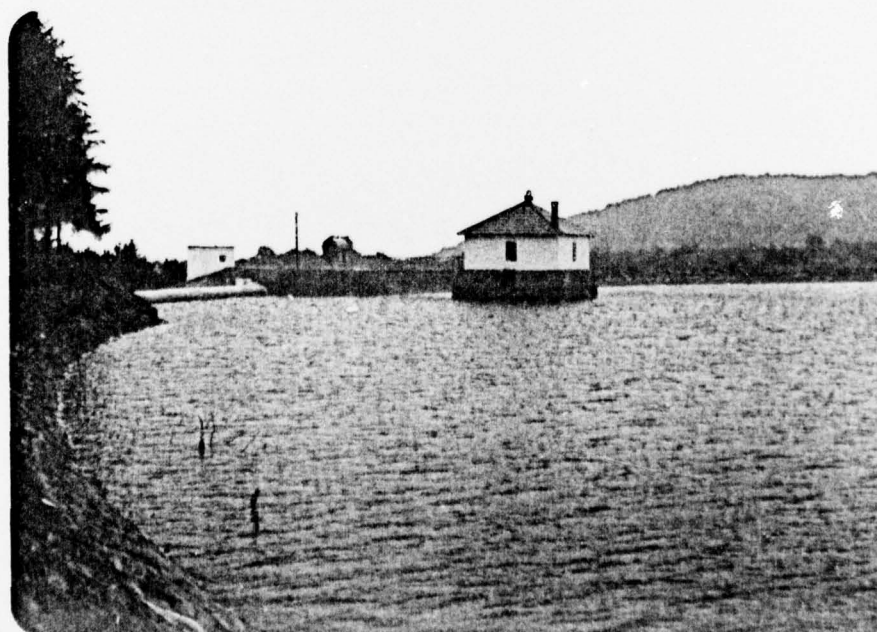
Photograph No. 2
Intake tower and spillway entrance.

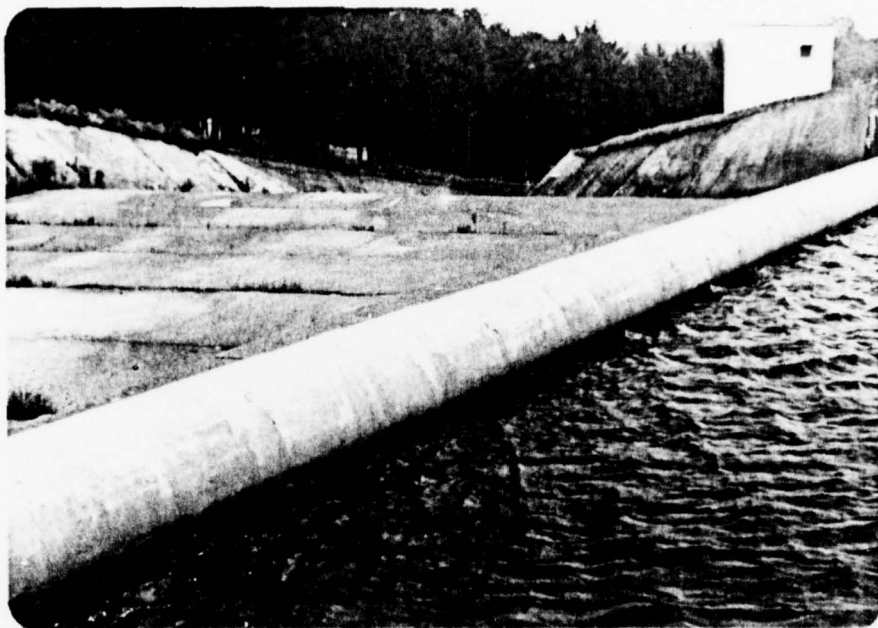
The maintenance condition of the control equipment for the Fabridam spillway gate is considered to be satisfactory. However, because a sudden release of water in the event of failure of the spillway gates may cause property damage downstream and considering the unique nature of the Fabridam spillway gates, it is considered advisable that these facilities be periodically inspected by engineers experienced in design, installation, and maintenance of such equipment.

Photograph No. 3
Fabridam spillway gates.

5. Due to the unique nature of the Fabridam spillway gates and since a sudden release of water in the event of their failure may cause property damage downstream by overflowing the channel in a residential area of Altoona, this appurtenance should be frequently inspected by personnel experienced in design, construction, maintenance, and operation of such equipment.

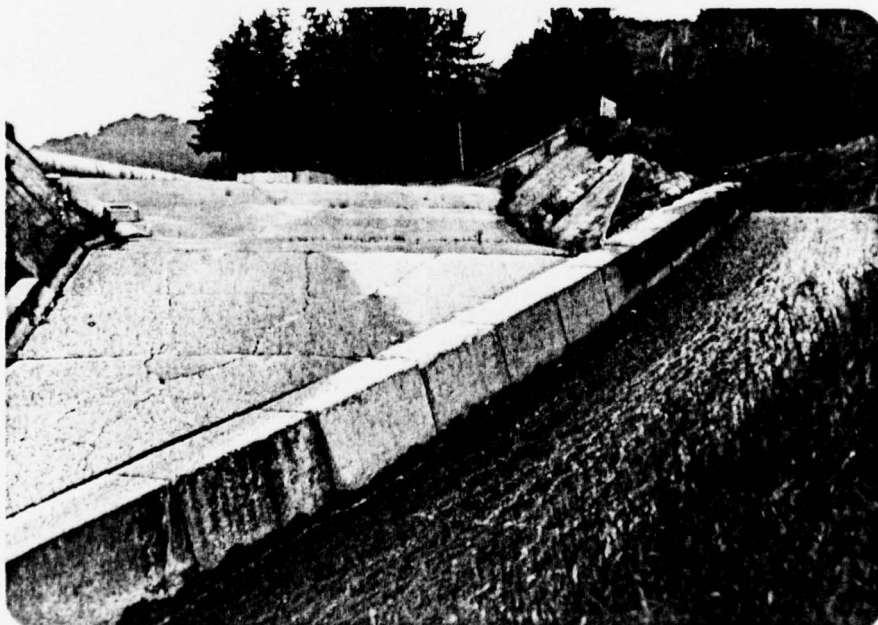
Photograph No. 4
Spillway chute.

4. The portion of the spillway wall that was reported as removed during the construction of the Fabridam gates should be replaced to eliminate the potential threat of high flows from the spillway discharging over the embankment and causing erosion of the downstream face of the dam.

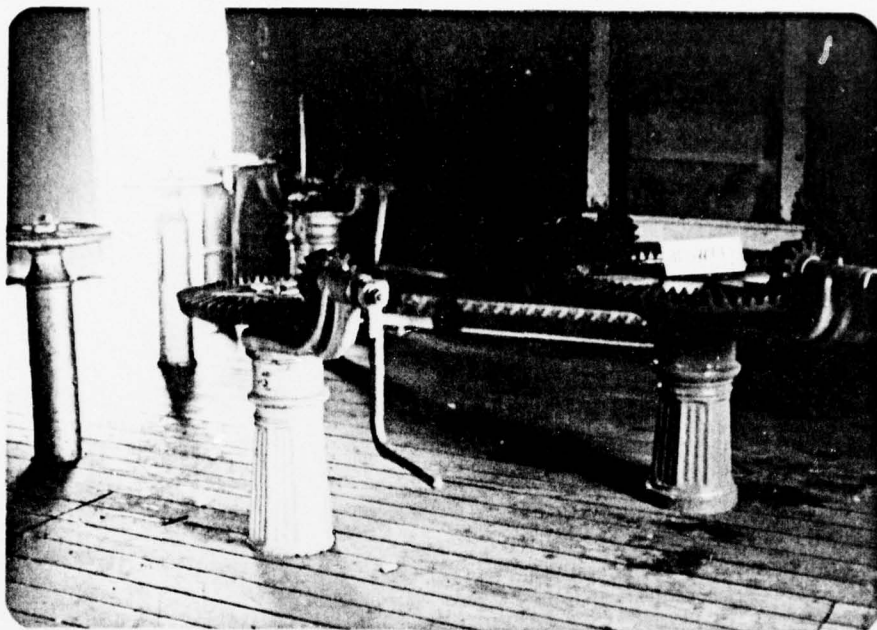
4.3 Maintenance of Operating Facilities. City maintenance personnel reported that the blow-off valve has not been functional. Visual observations indicate that the operating equipment is in poor condition.

Photograph No. 5
Valve controls at intake tower.

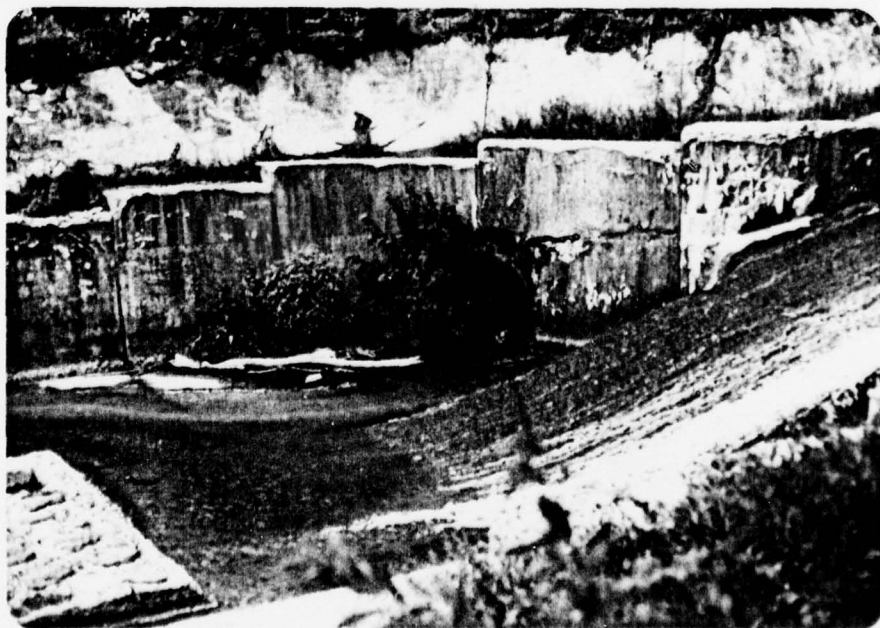
The condition of the operational facilities is considered to be poor. It was reported that the blow-off valve is not functional.

Photograph No. 6
Blow-off pipe.

1. The owner should initiate additional hydrology and hydraulic studies to more accurately ascertain the spillway capacity and to determine the nature and extent of remedial measures required to increase the spillway capacity.
2. It is recommended that the owner immediately evaluate the operational condition of the blow-off pipe valve and perform necessary maintenance and adequately maintain the equipment.

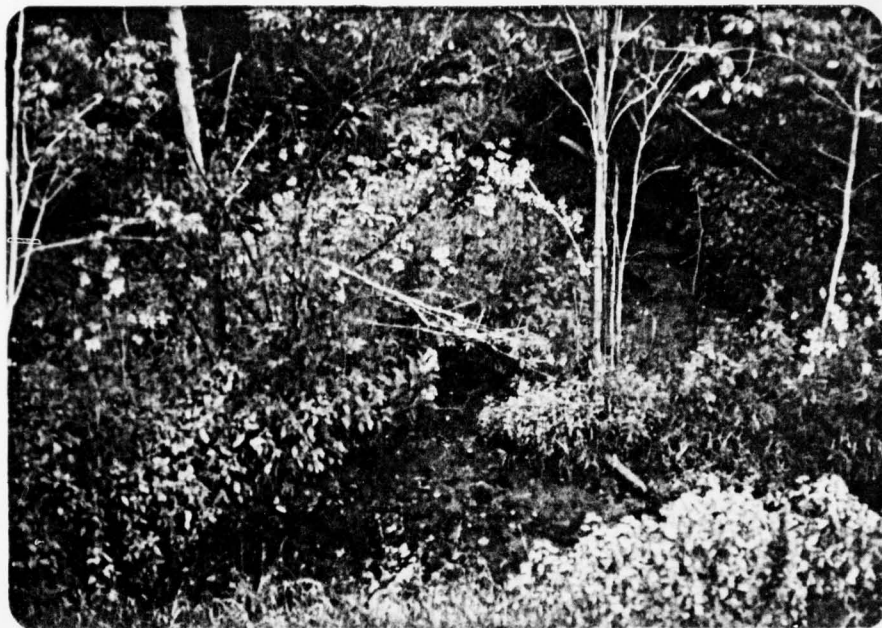
b. Embankment. The general inspection of the embankment consists of searching for indications of structural distress, such as cracks, subsidence, bulging, wet areas, seeps and boils, and observing general maintenance conditions, vegetative cover, erosion and other surficial features. Extensive wet areas were found downstream from the toe of the dam. The wet areas included numerous pools of perched water. Although no significant flow was observed, it is possible that perched water is fed by seepage through the dam.

Photograph No. 7
Perched water along the toe.

3. Brush and trees below the toe of the dam should be cleared to the limit of the ponded area and this area regraded to drain the ponded water. The quantity of flow from this area should be measured and recorded, and the turbidity of the flow should be noted. If flow increases, a detailed study and necessary remedial action should be undertaken.

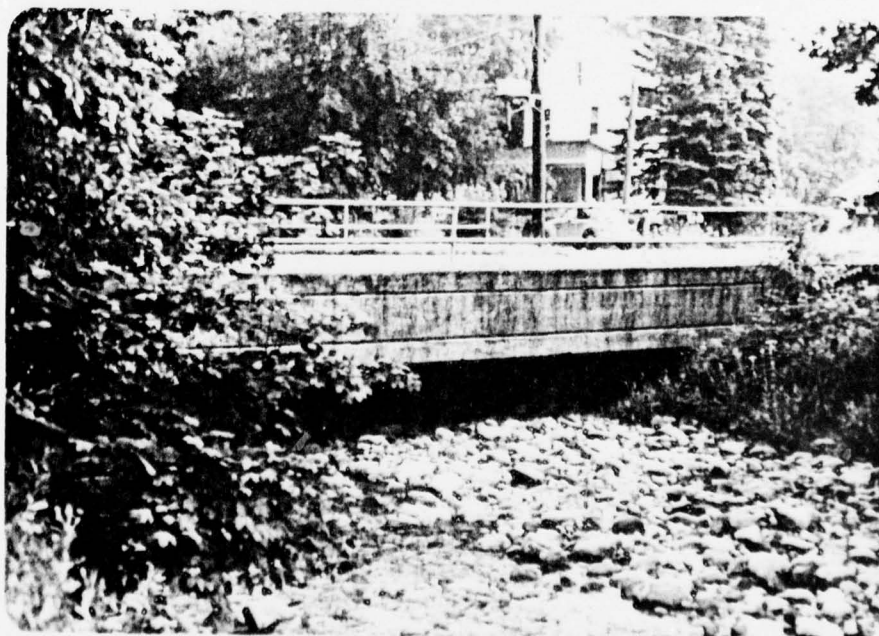
Photograph No. 8
Typical downstream channel (through Altoona).
